Connecting The Bike Network

Intersection Diverter
Tyler St. and Broadway Ave.

Eugene Neighborhood Greenways 2.0
Redesigning Streets for Bike & Pedestrian Mobility

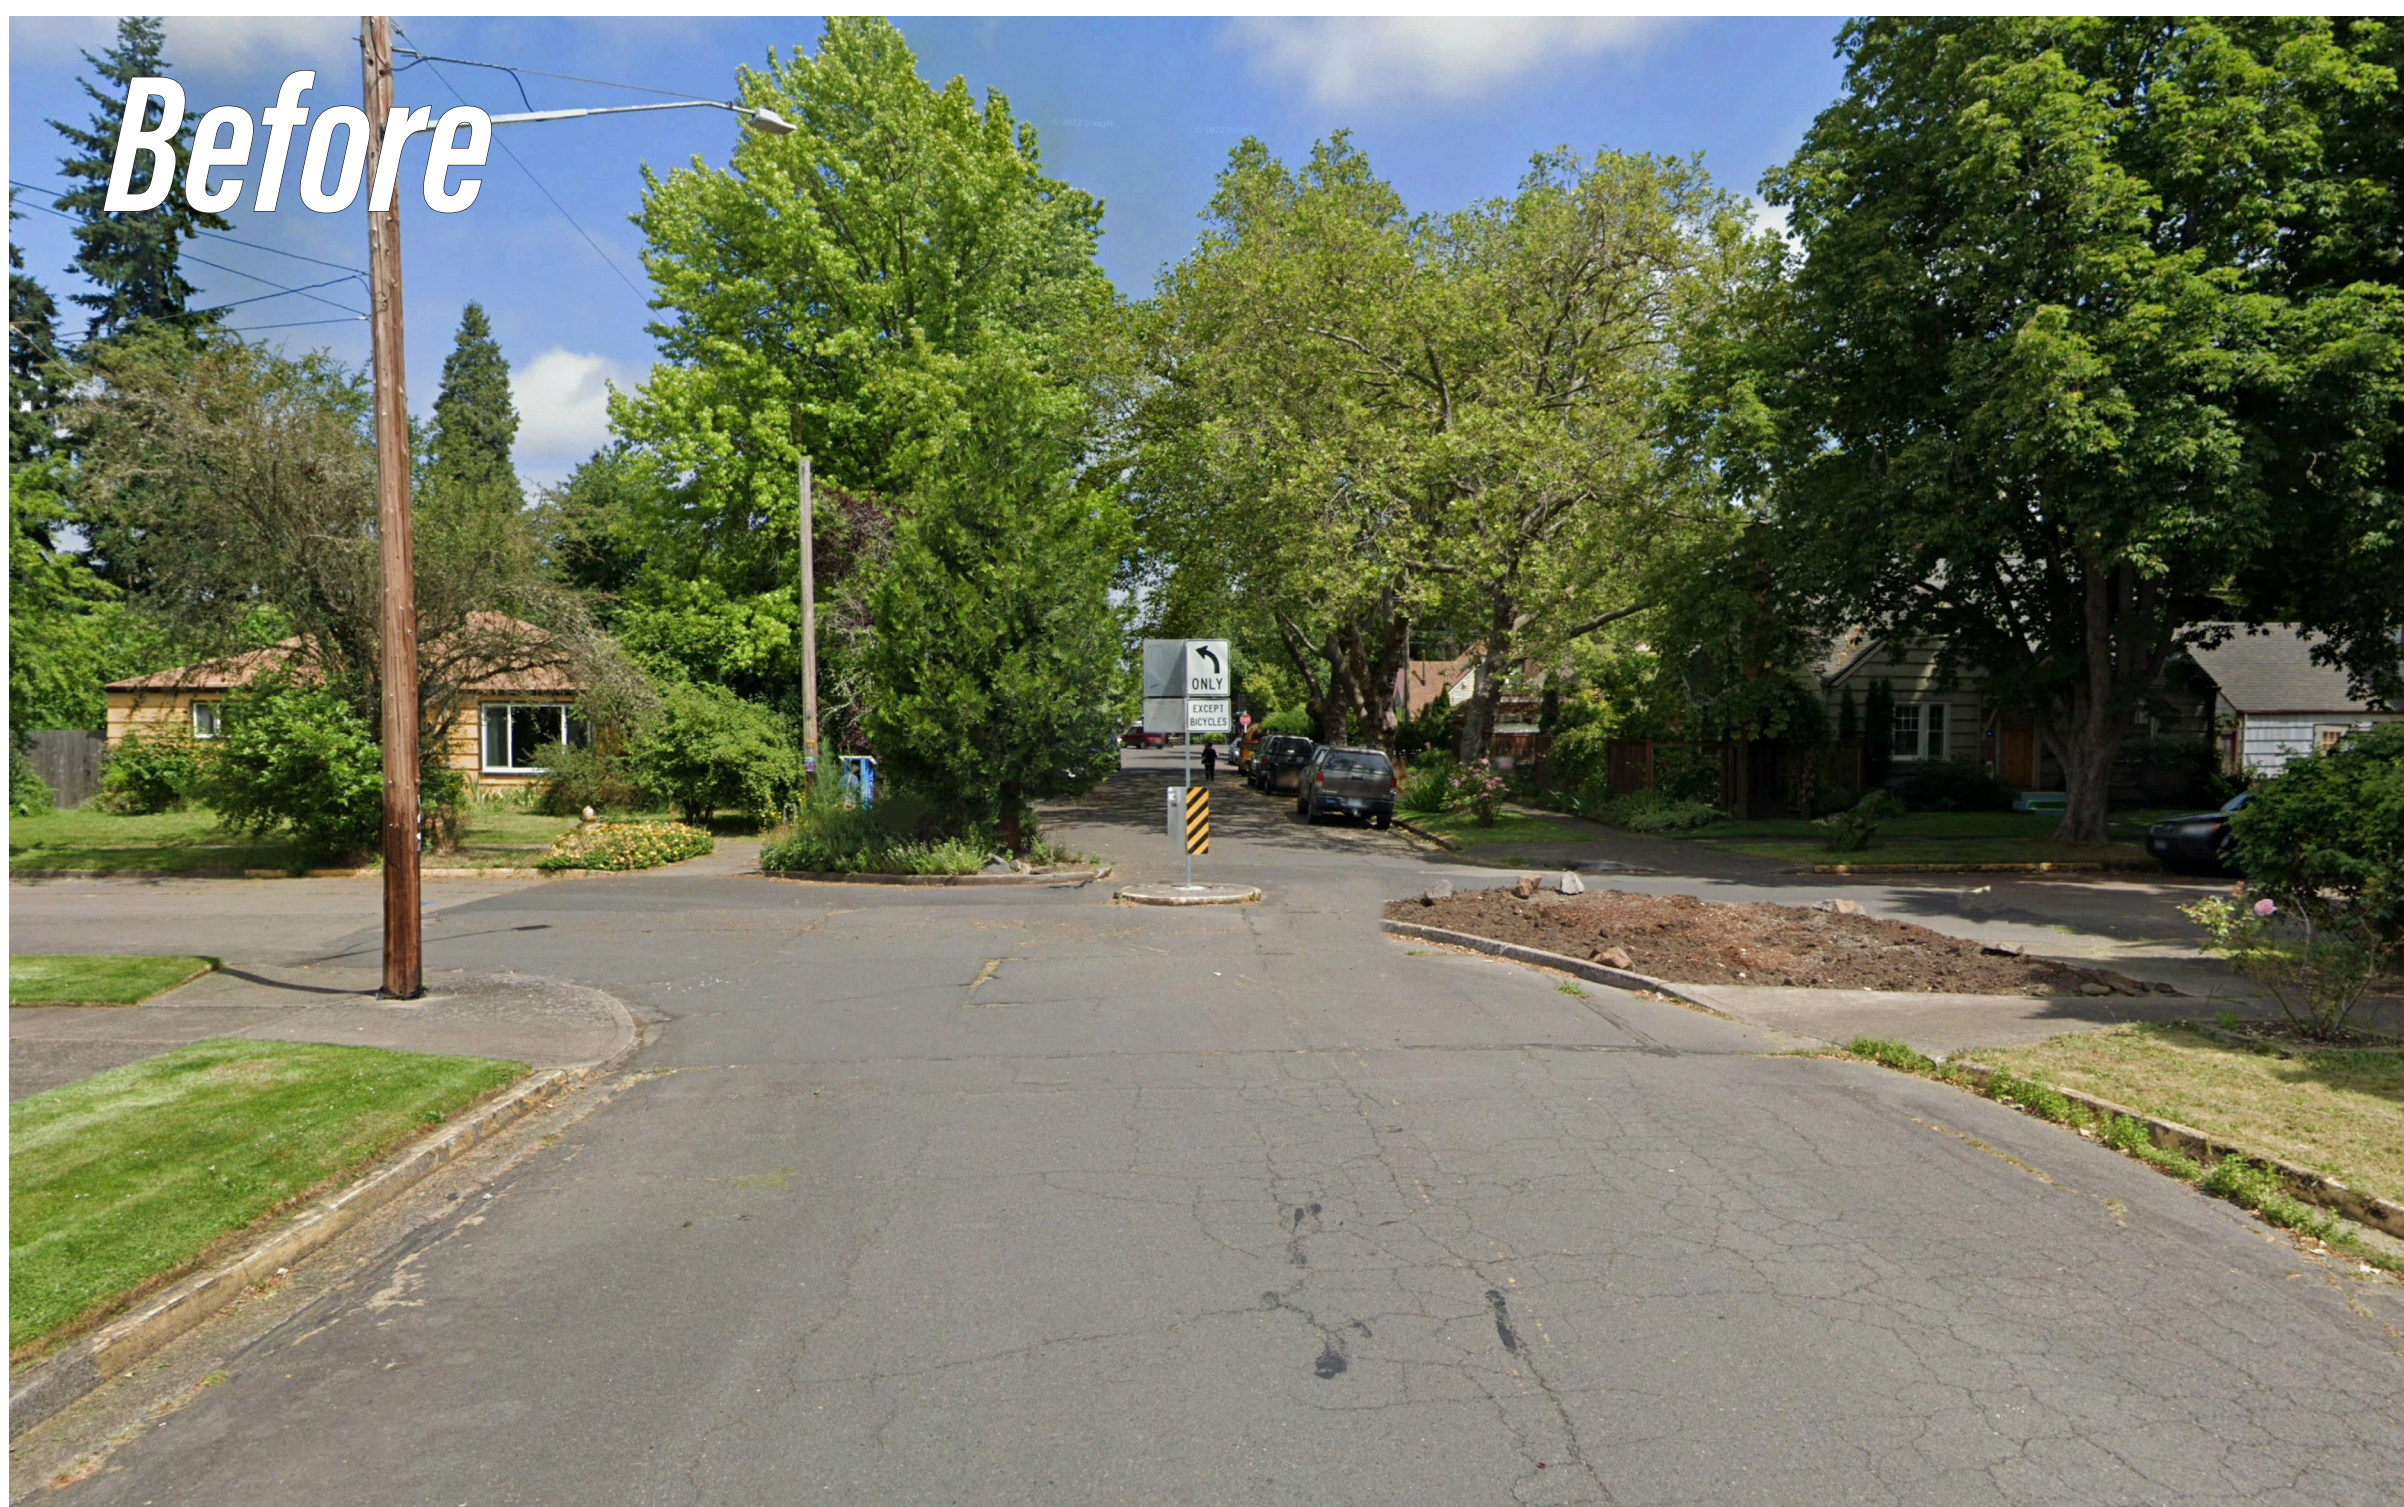
Safety

- Long crossing distance for pedestrians
- Signpost creates a hazard for cyclists who may strike it as they pass
- Narrow bike pass-through
- Difficult left turn with high volumes of cyclists adding to risk of collision

Mobility

- Current design allows to take the turn quickly creating conflict with merging cyclists
- Signage fails to communicate to cyclists who are unfamiliar with the route
- Adjacent neighborhood streets are over-used by car through-traffic

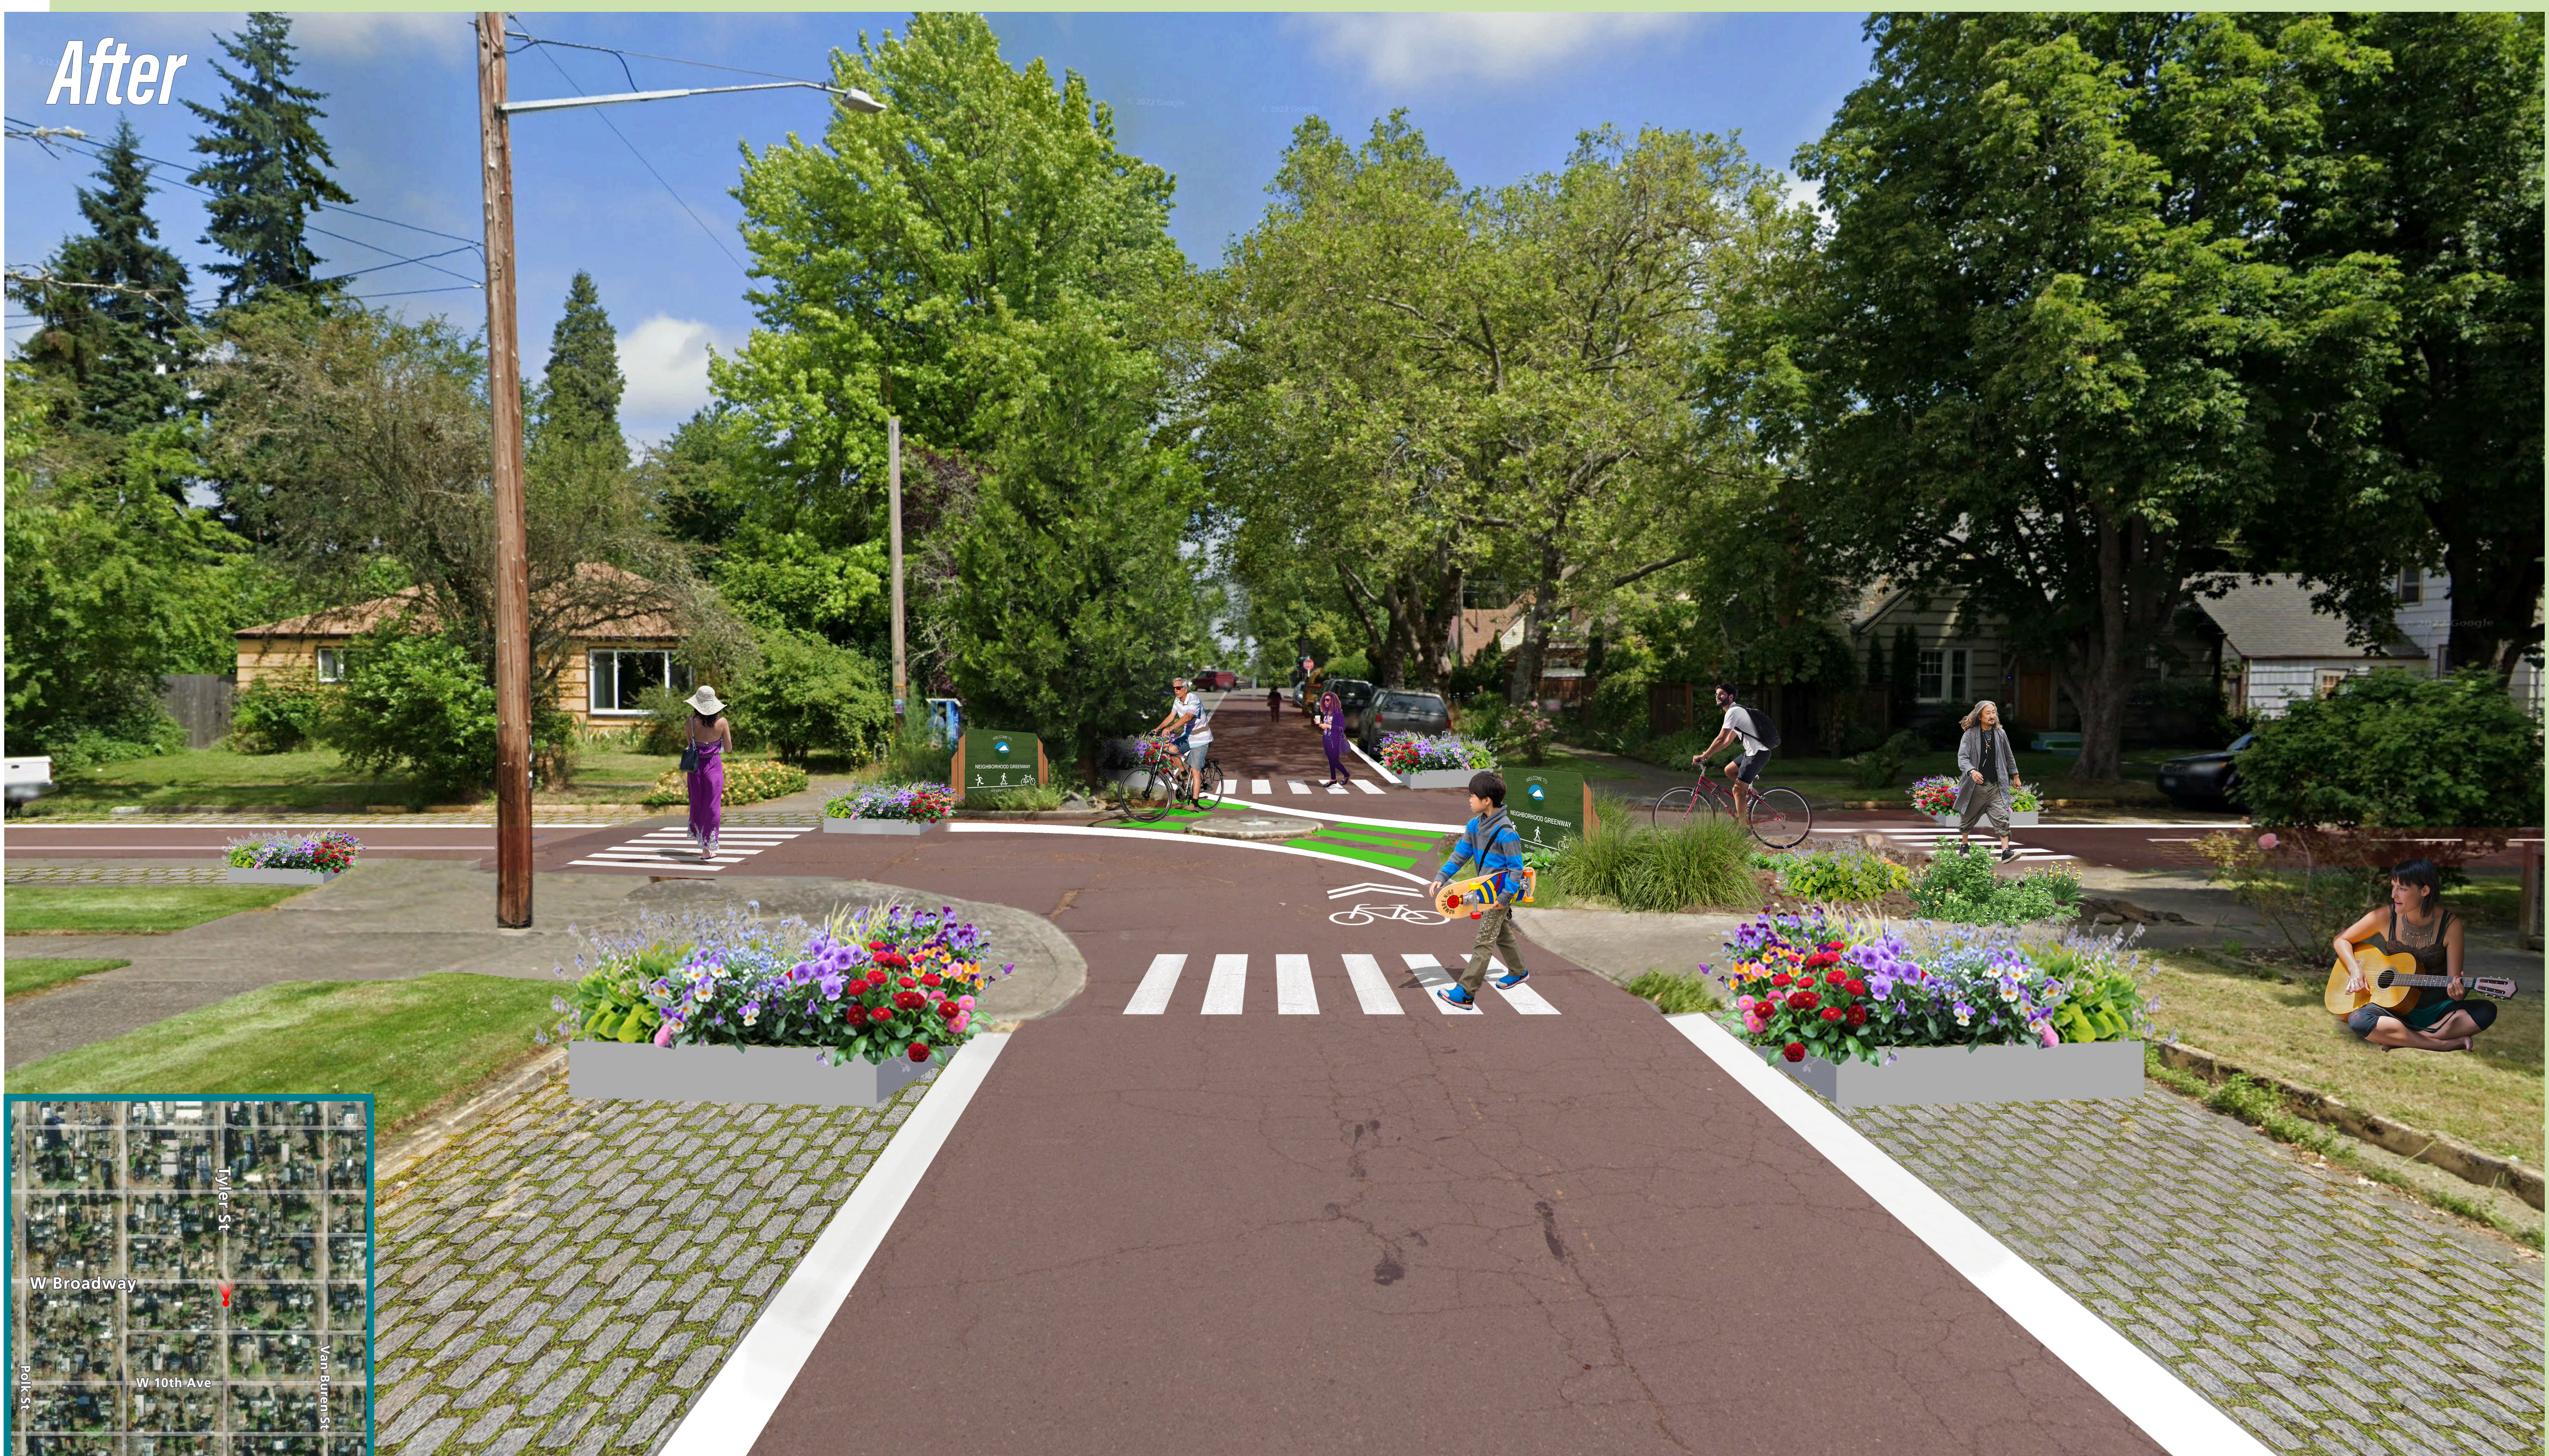
Safety

- Planters protect Pedestrians and cyclists as they cross
- Painted turn lines are visible from further away than current signage
- Removed signage and widened bike cut-through reduce the risk of cyclists crashing into fixed objects

Mobility

- Signs on both sides of the cut-through are visible to cyclists approaching from any direction
- Green paint and sharrow demonstrate the direction of travel for cyclists
- Slowed car speeds make the intersection safer for all modes
